Regarding: Reserve Study Final Version

Level 1, Platinum Reserve Analysis

# Serenity Ridge Owners Association Smokey Hill Rd. & Oak Hill Aurora, CO. 80016

## FINAL VERSION

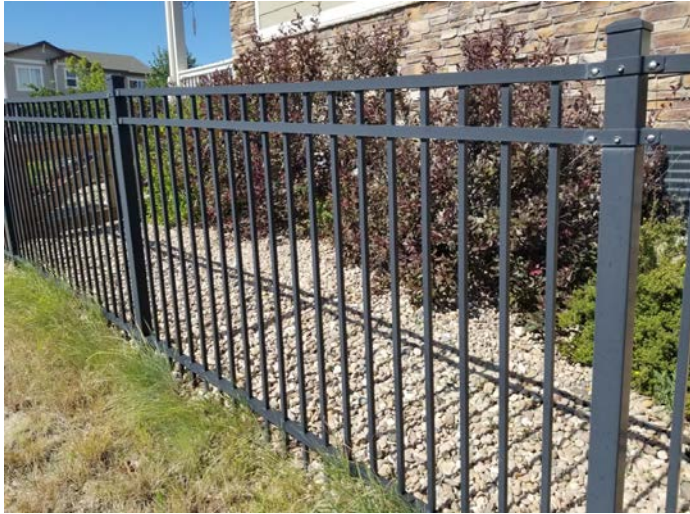
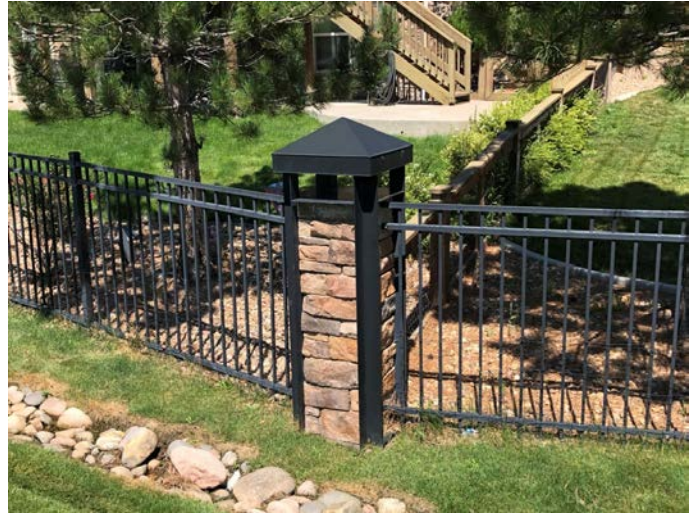
Comp #: 207    Metal Fencing - Repaint (Ph 1)

- This type of fence should be repainted every 4 - 5 years to protect the metal from deterioration
- The proper way to paint aluminum fencing is by cleaning the surface, remove any loose or flaking paint, apply a primer so the paint adheres to the surface properly, then application of new paint. By following this process, paint should last 7 - 10 years, as opposed to 4 - 6 years if proper prep is not followed.

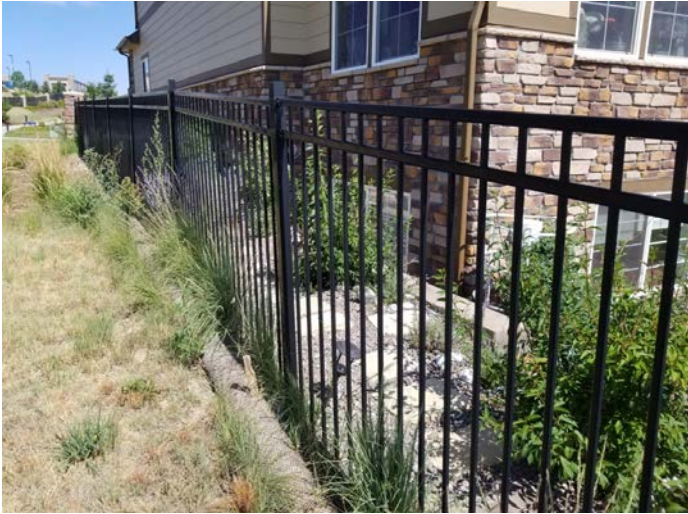
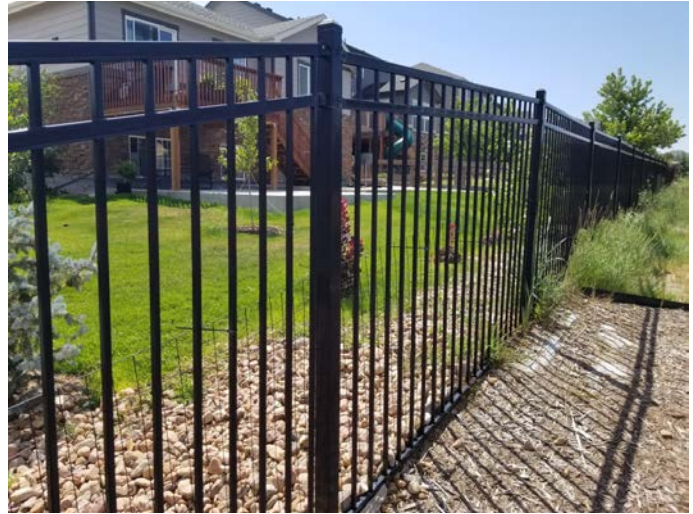
Comp #: 207    Metal Fencing - Repaint (Ph 2)

- This type of fence should be repainted every 4 - 5 years to protect the metal from deterioration
- The proper way to paint aluminum fencing is by cleaning the surface, remove any loose or flaking paint, apply a primer so the paint adheres to the surface properly, then application of new paint. By following this process, paint should last 7 - 10 years, as opposed to 4 - 6 years if proper prep is not followed.
- If proper painting techniques are followed, we can adjust the life expectancy in future report updates.

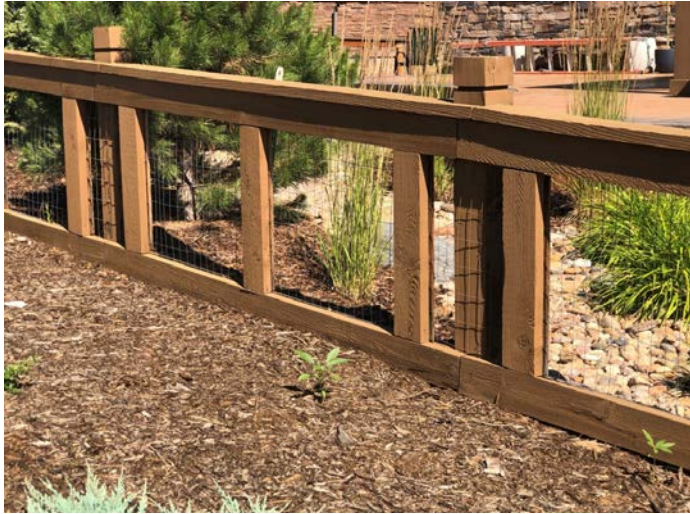
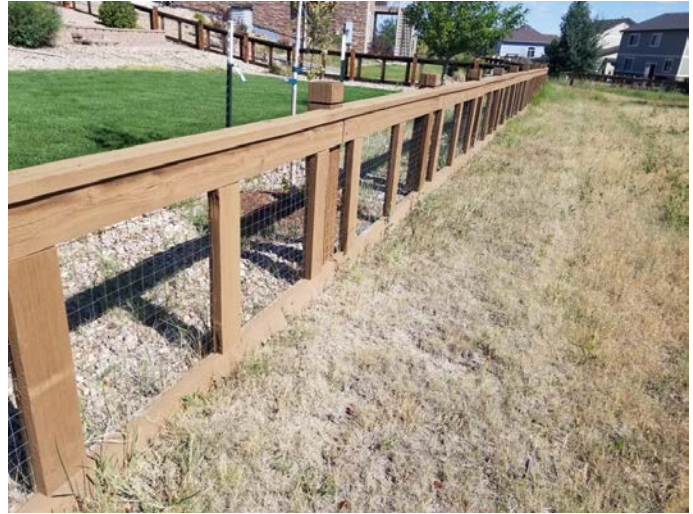
Comp #: 209    Wood Fencing - Restain

- In this climate, we recommend staining wood fences every 3 - 4 years to maintain appearance and protect wood surfaces from exposure to elements that will cause deterioration.

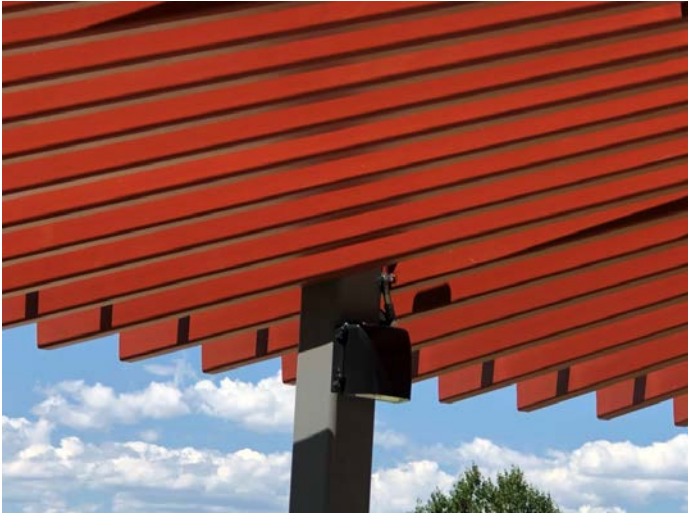
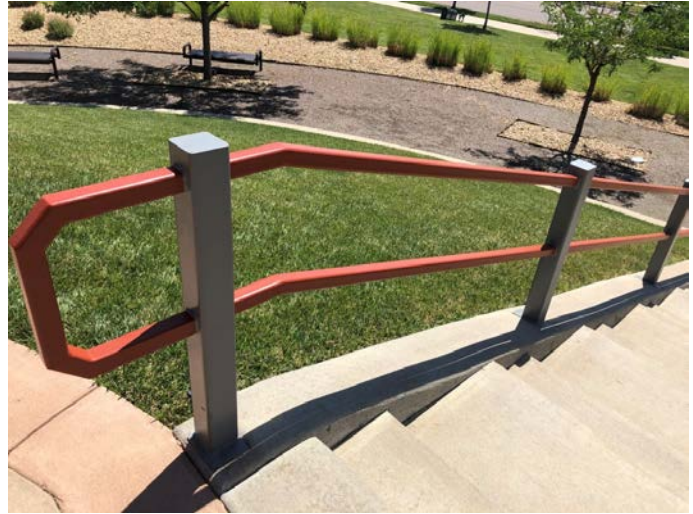
Comp #: 212 Gazebo and Rail - Repaint

- Surfaces were repainted in 2017 and are in good condition.
- Expect to paint these surfaces approximately every 7 - 10 years to maintain appearance and protect metal surfaces.
- Remaining life based on current condition.
- Coordinate with other metal painted surfaces for best cost estimate.

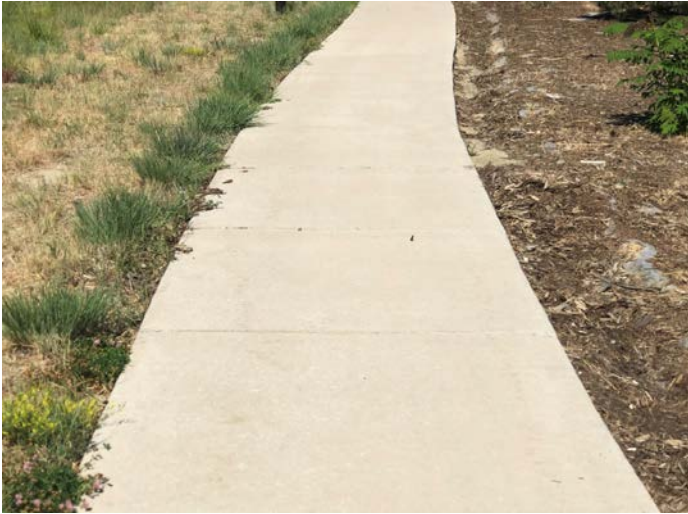
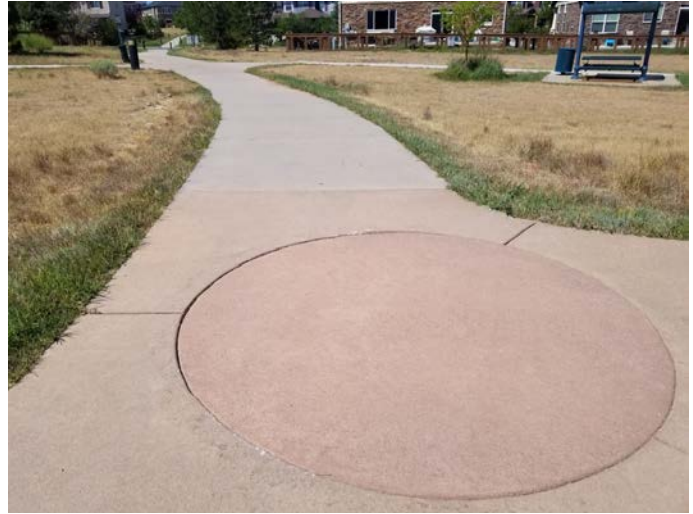
Comp #: 601 Concrete Sidewalks - Repair

- Conditions vary throughout. No significant trip hazards or settling areas that require replacement at this time
- It is unlikely that all areas will fail and need to be replaced at the same time.
- Therefore, we set an allowance of 10% of the total area measured (5200 GSF) to be repaired every 4 years.
- As the property ages, it is likely that the percentage of repairs will need to be adjusted in future Reserve Study updates.

Allowance to repair 10% of area every 4 years

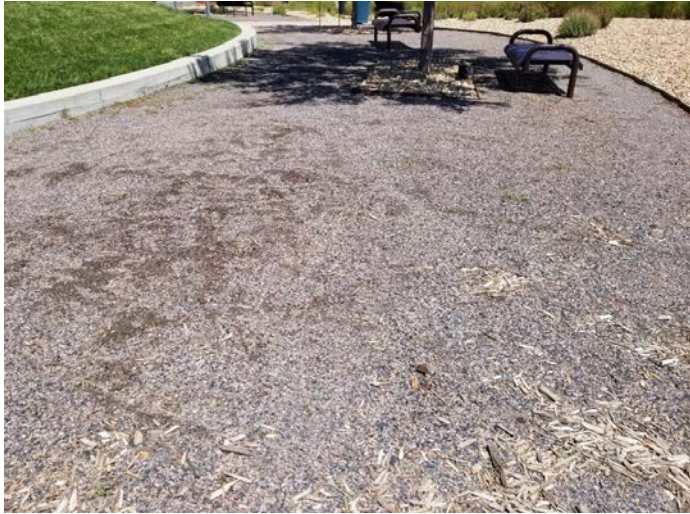
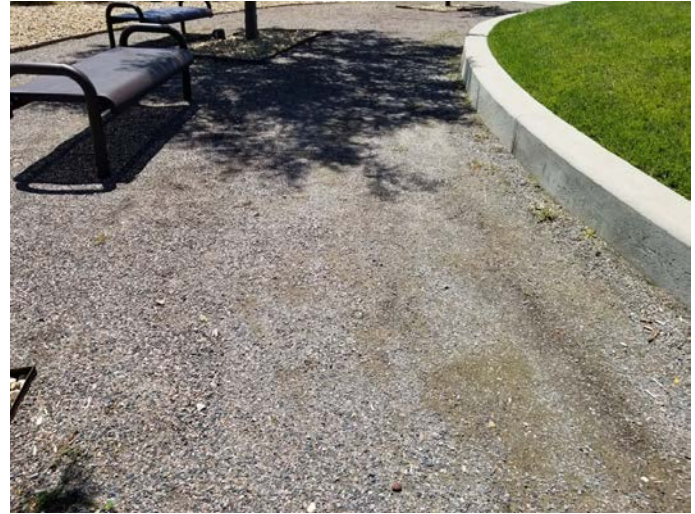
Comp #: 625    Breeze/Crushed Granite - Replenish

- Appears new material was installed within the past couple years.
- Due to the level of use these areas receive, the area will be subject to frequent wash outs and continual high maintenance requirements
- We recommend addressing these areas every 3 years with new material and cutting back any overgrown areas.

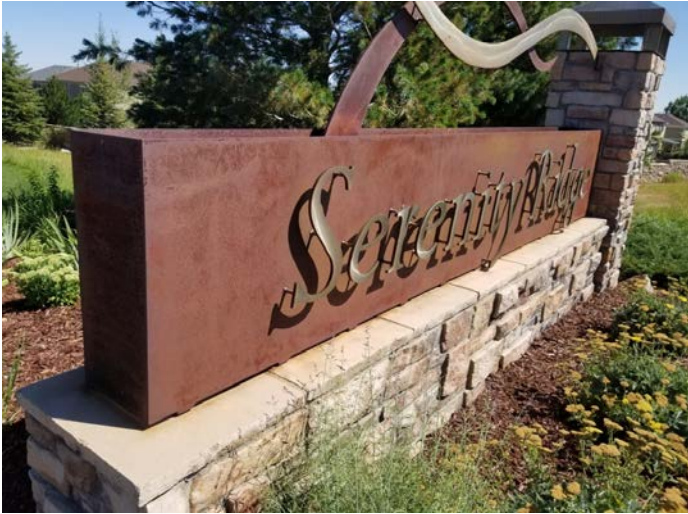
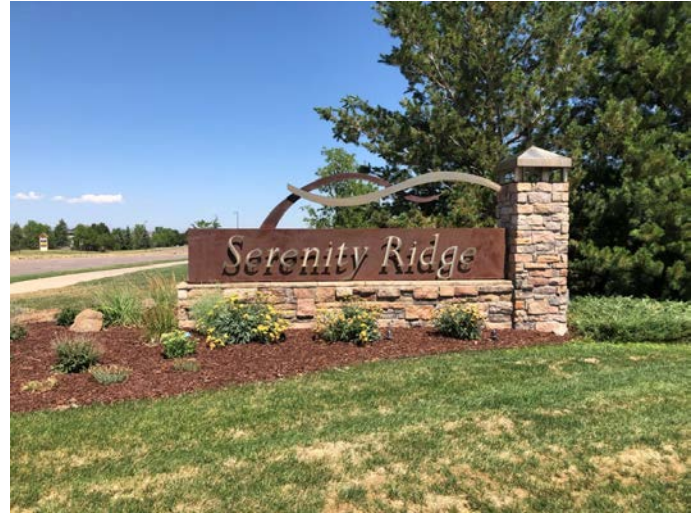
Comp #: 801    Monument - Refurbish

- The monument structure appeared in good condition at time of observation with no noticeable damage to the materials.
- It is unlikely that the monument will require replacement or rebuilding due to the materials failing. However, due to changes in decorative tastes, we recommend reserving to update the monument every 20 - 25 years to ensure an appropriate and attractive appearance to the community entrance.

Allowance for general repairs

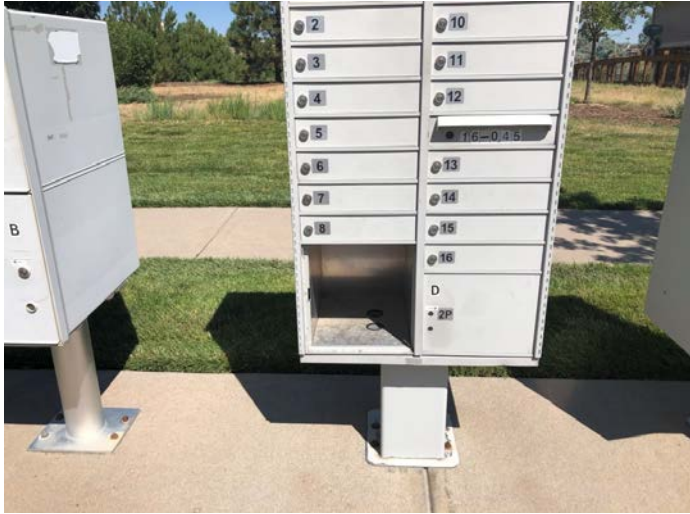
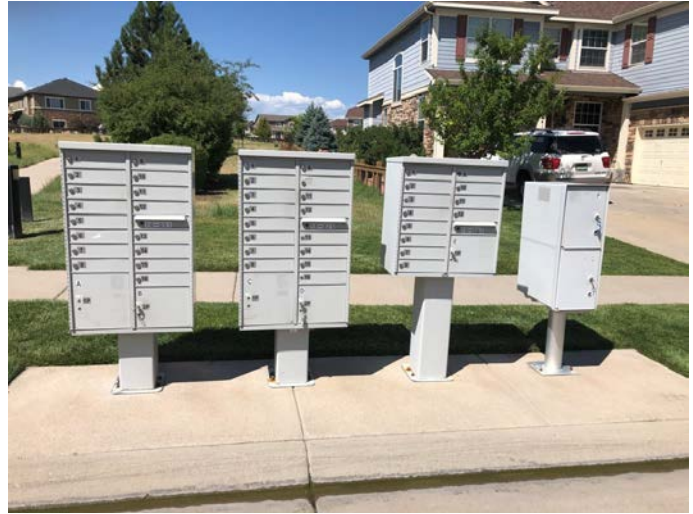
Comp #: 803    Mailboxes - Replace (2004)

- Per Postal regulations effective 2012, "all customers are responsible for repairs and replacement of keys, locks, or the boxes/cluster units themselves".
- Based on our experience, these boxes will have a life expectancy of 15 - 25 years due to location and quality.
- Remaining life is based on age and observed condition.

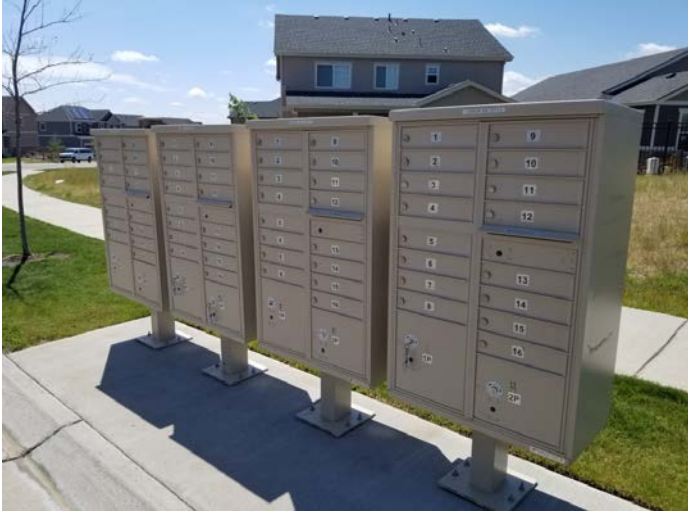
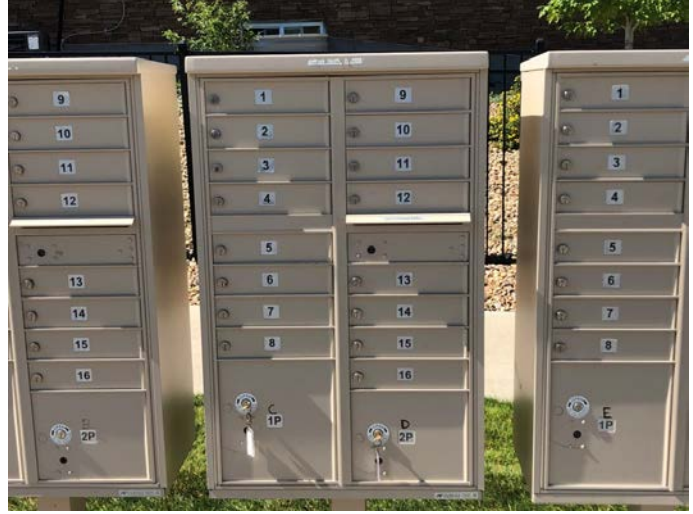
Comp #: 803    Mailboxes - Replace (2015)

- Per Postal regulations effective 2012, "all customers are responsible for repairs and replacement of keys, locks, or the boxes/cluster units themselves".
- Based on our experience, these boxes will have a life expectancy of 15 - 25 years due to location and quality.
- Remaining life is based on age and observed condition.

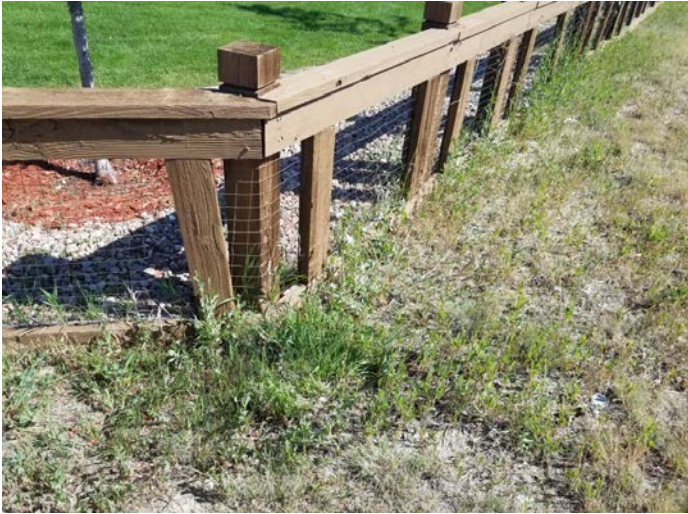
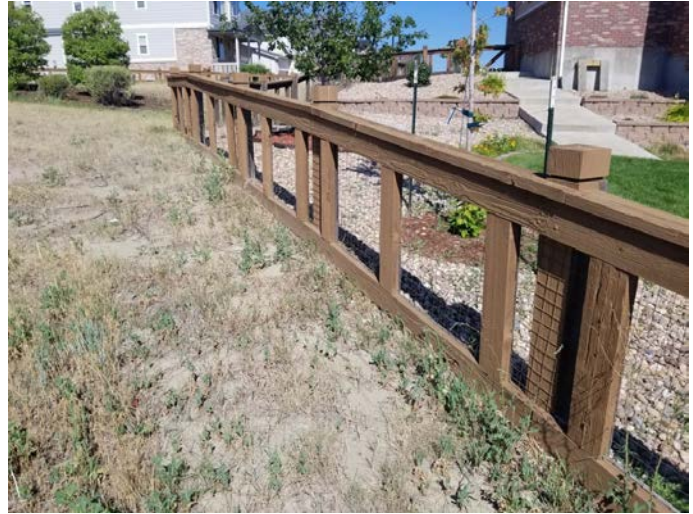
Comp #: 1001 Wood Fencing - Replace (Ph 1)

- This fencing was installed in the mid 2000's (2004 - 2006). Current conditions exhibit some warping and splitting of boards. Majority of the damage is on the top cap boards and some side rails.
- Major repairs should be handled as prep work before staining, or as an operating expense.
- Remaining life is based on the average age of the fence.

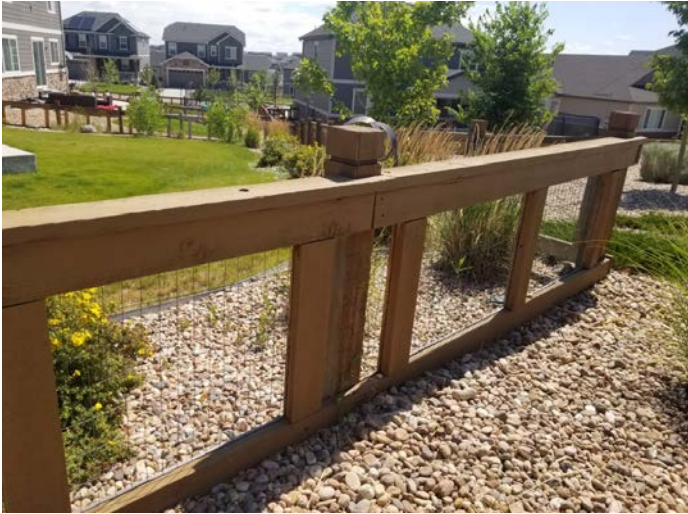
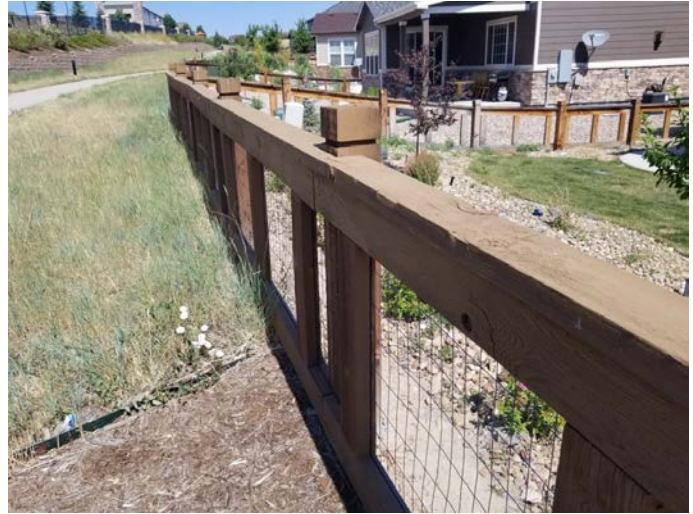
Comp #: 1001 Wood Fencing - Replace (Ph 2)

- This fencing was installed in the mid 2010's (2014 - 2016). Current conditions exhibit some warping and splitting of boards. Majority of the damage is on the top cap boards and some side rails.
- Major repairs should be handled as prep work before staining, or as an operating expense.
- Remaining life is based on the average age of the fence.

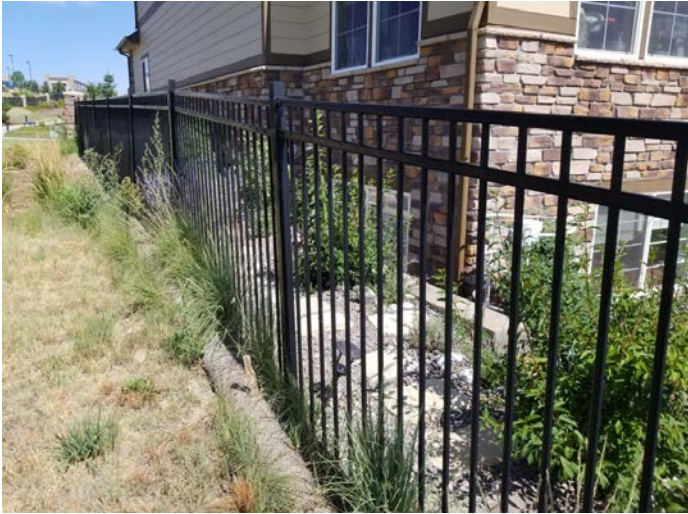
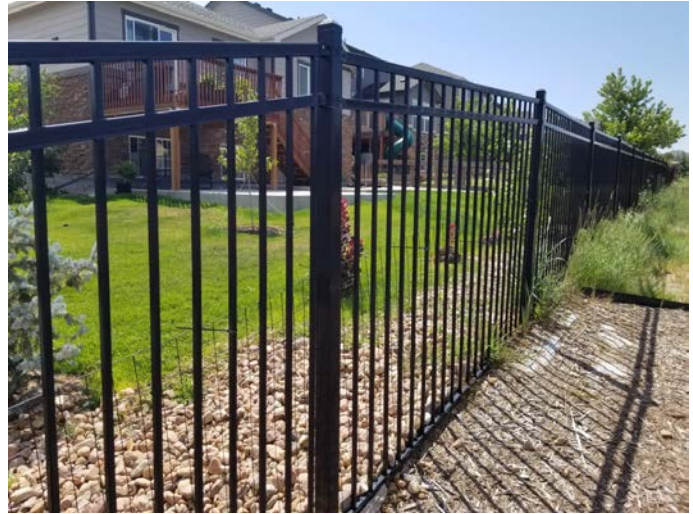
Comp #: 1002 Metal Fencing - Replace (Ph 2)

- The average life expectancy for metal fences ranges between 25 - 35 years, depending on maintenance schedules and exposure to elements.
- The remaining life is based on age of fence and observed conditions.

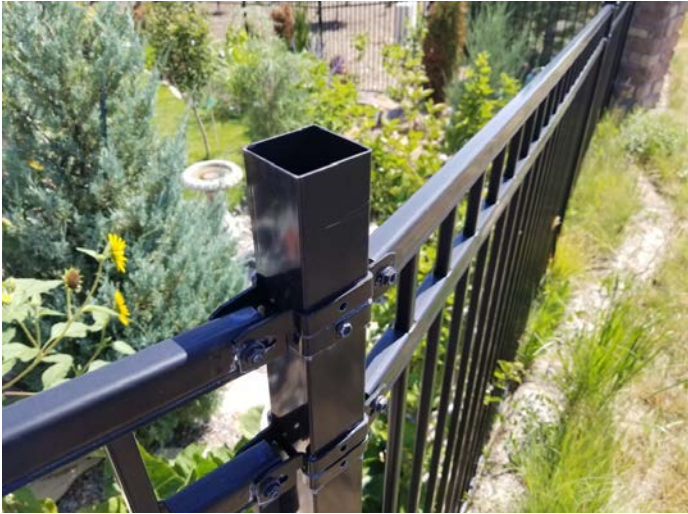
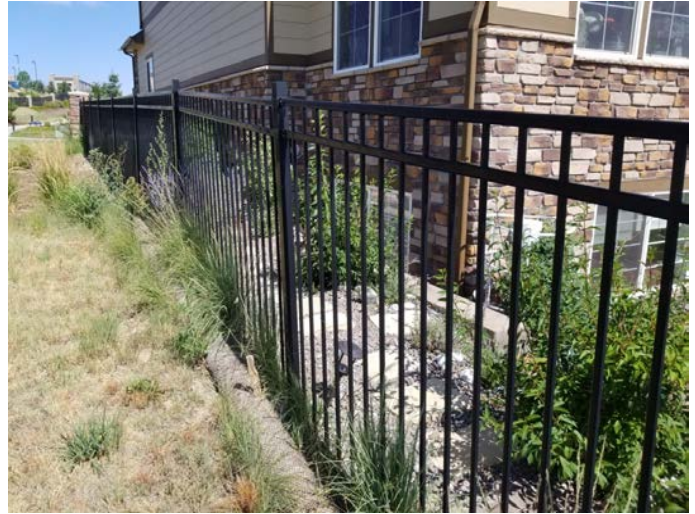
Comp #: 1002 Metal Fencing - Replace (Ph 1)

- The average life expectancy for metal fences ranges between 25 - 35 years, depending on maintenance schedules and exposure to elements.
- The remaining life is based on age of fence and observed conditions.

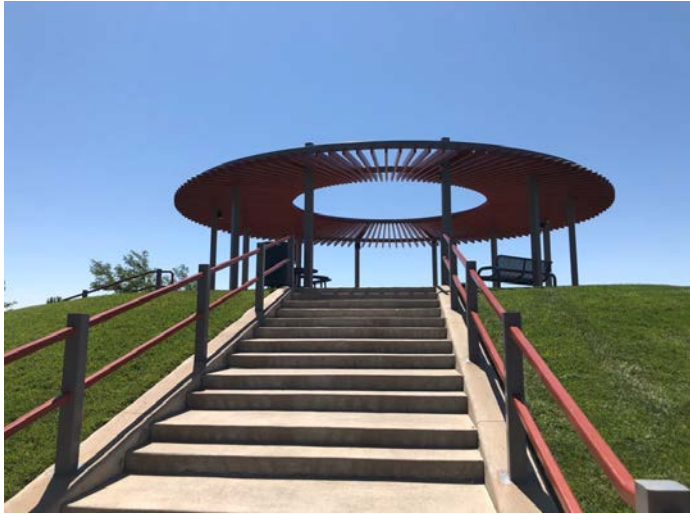
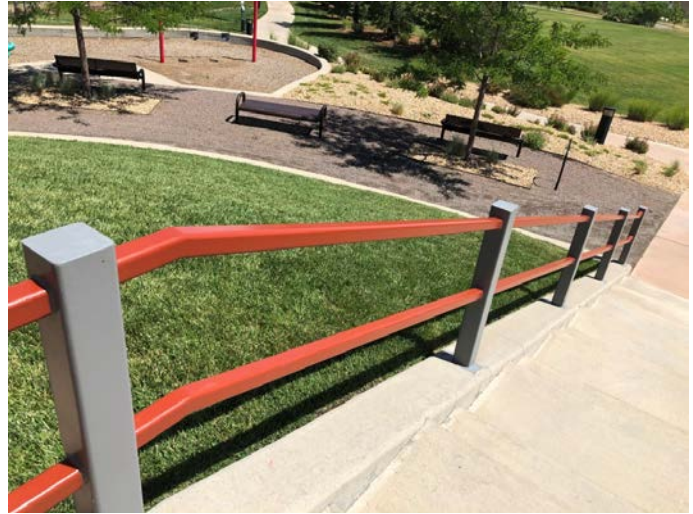
Comp #: 1003 Gazebo and Rails - Replace

- Structure is well maintained and painted frequently. As a result, it is unlikely that this structure and rail system will ever have to be replaced, as long as proper maintenance continues.
- According to the manufacturer, this component should have a 50+ year life expectancy under normal conditions and with frequent painting.
- Reserve funding to replace this component is not required at this time.
- The original installed cost of this structure and the rails in 2004 was between \$125,000 and \$135,000.

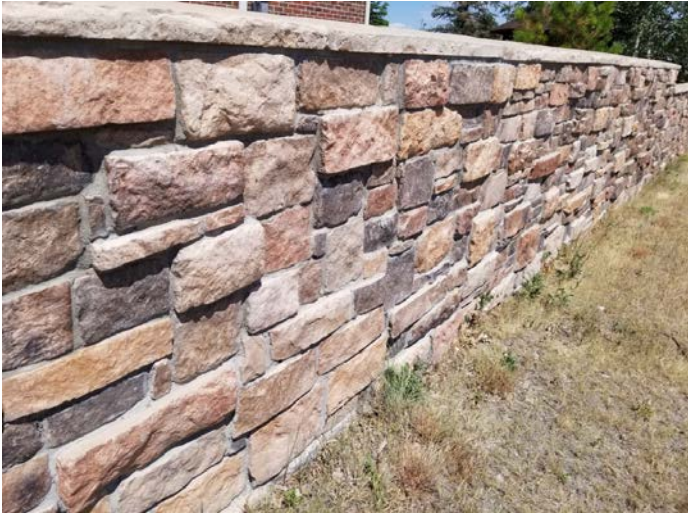
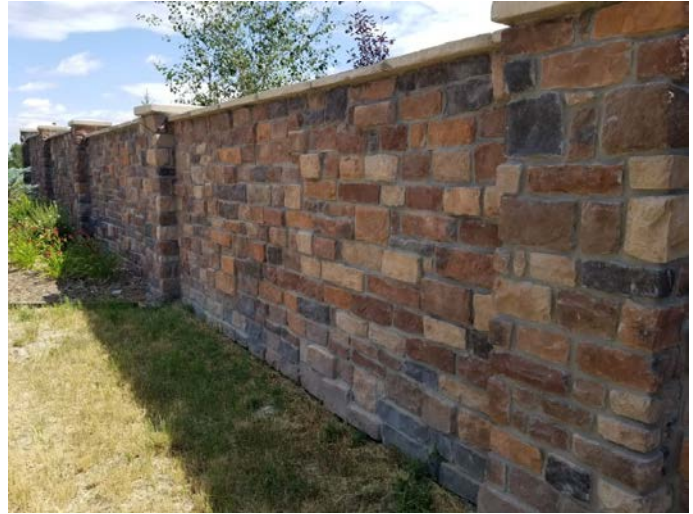
Comp #: 1005 Rock Wall/Columns - Major Repairs

- A few minor cracks and grout issues were noted on the wall behind E. Geddes Circle. Other walls were in good condition with no problems noted.
- While it is unlikely that the entire column or wall will need to be replaced, it is likely that periodic repairs may be necessary to replace loose or missing stones.
- Depending on the effects from weather, we suggest establishing a Reserve fund for periodic repairs to the columns and walls every 10 years.

Estimate for major repairs

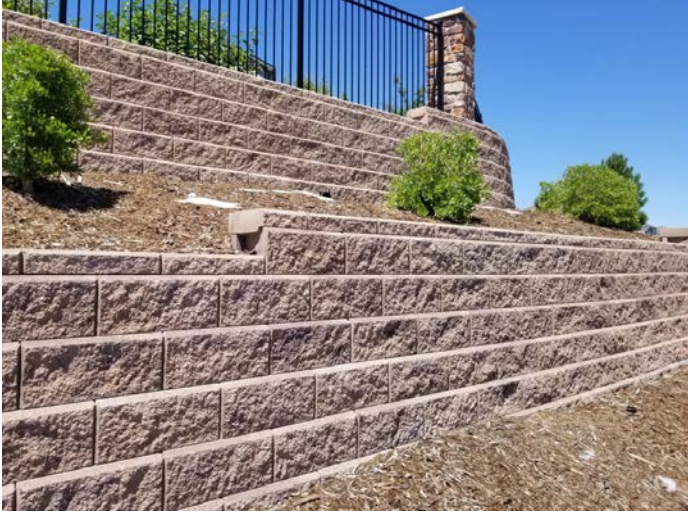
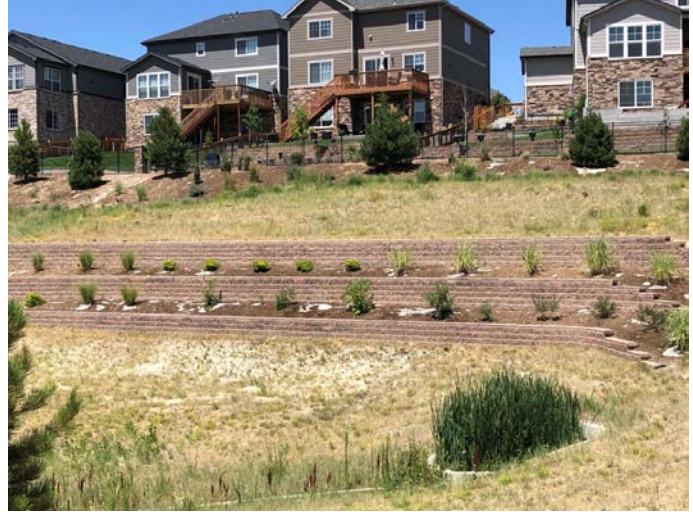
Comp #: 1011 Retaining Wall - Replace

- As long as retaining block walls were installed conforming to county code requirements, walls should have an extended useful life.
- This type of material has an indefinite life expectancy and complete replacement is unlikely.
- Therefore, Reserve funding is not required for this component at this time.
- Continue to monitor conditions in future Reserve Study updates and adjust funding requirements if required.

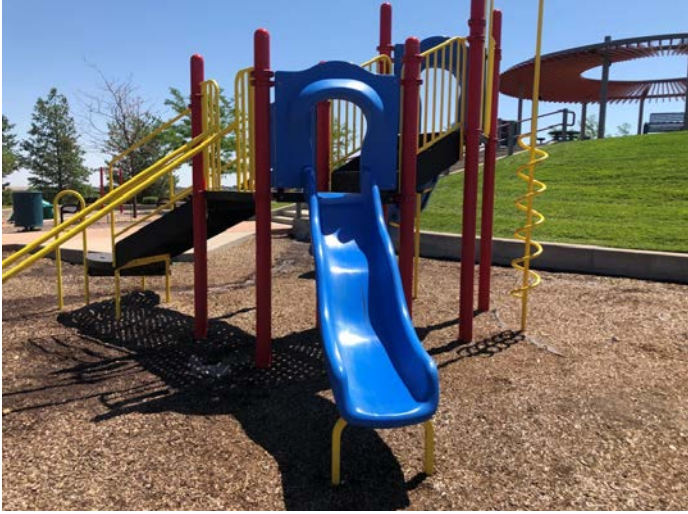
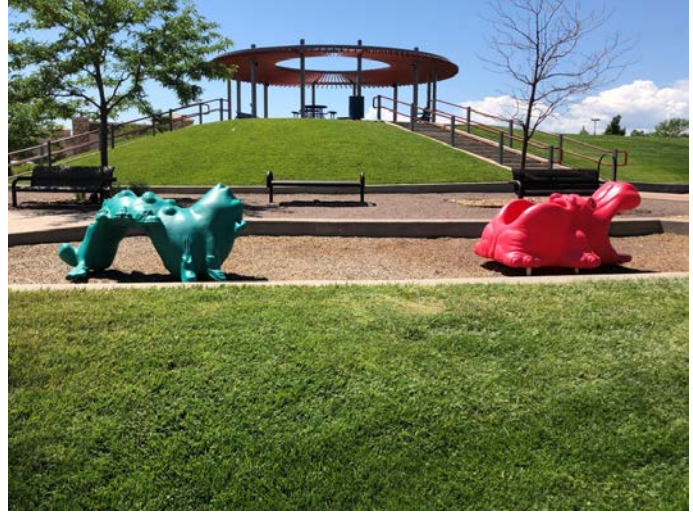
Comp #: 1301 Play Equipment - Replace

- Depending on overall level of use and care, the average life expectancy for play equipment ranges from 15 - 18 years.
- Expect high use for this facility due to the demographics of the community with the majority being young families with children.
- Manufacturer of equipment is "Little Tykes".

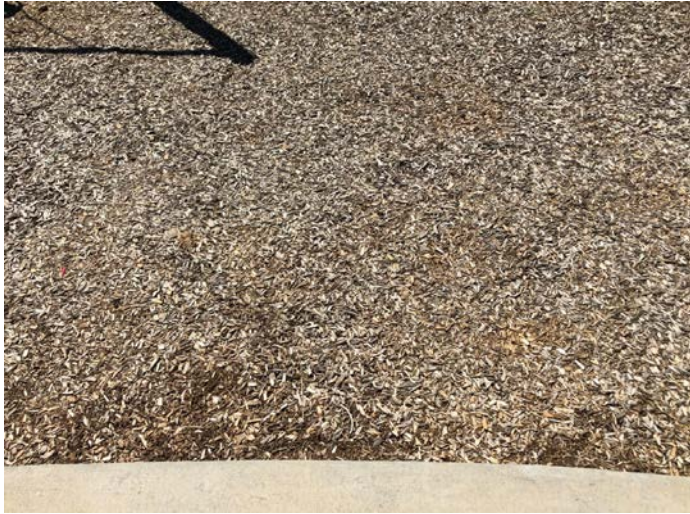
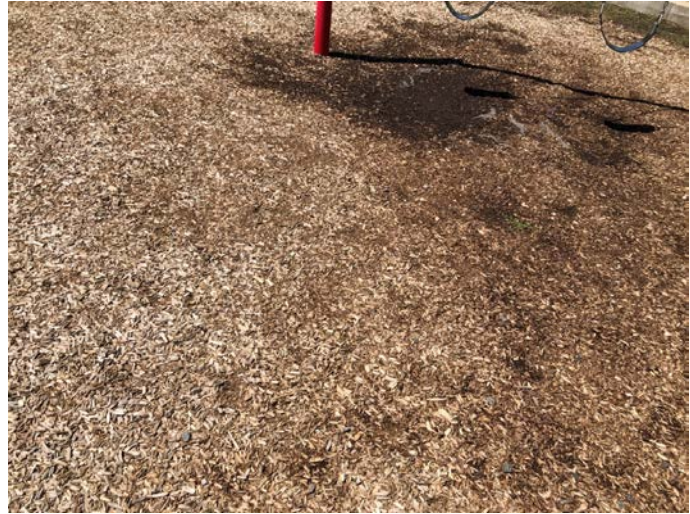
Comp #: 1303 Tot Lot Groundcover - Replenish

- Some low areas noted, especially at the ends of the slides, and under the swings. We recommend the landscaper spread out the materials to even out the coverage.
- Depending on the level of use and care, expect to refill groundcover bed every 3 to 5 years to maintain appearance and ensure proper function as a safety component.
- Remaining life is based on the observed conditions and the overall "feel" of the cushion in the material.

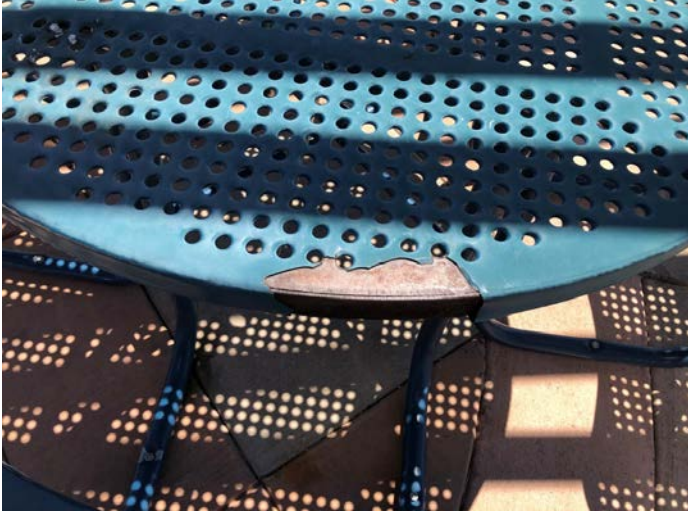
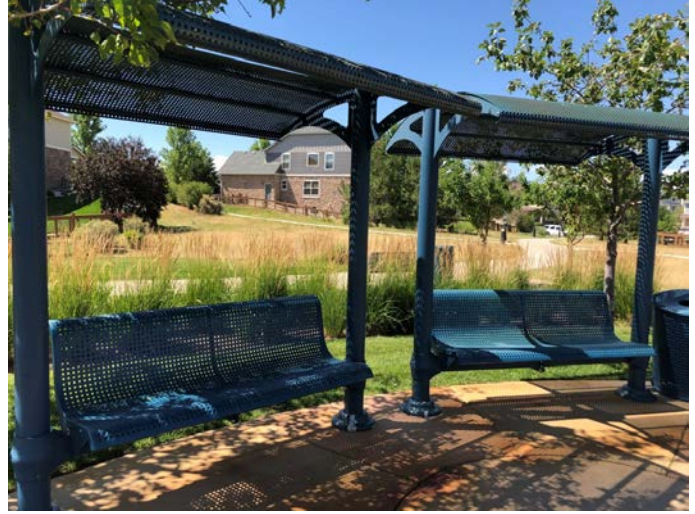
Comp #: 1307 Park Accessories - Replace (Tract B)

- Extensive sun damage and some rusting and loss of thermoplastic coating noted. These were installed in 2005
- Depending on the level of use, expect to replace equipment every 10 - 15 years. Factors that contribute to a shorter replacement cycle include abuse, vandalism, and effects from weather.
- While pieces can be replaced on an as needed basis, we suggest replacing all at the same time to get the best replacement cost possible and to ensure types of equipment matches in design.
- Remaining life is based on the observed conditions.

Allowance to replace

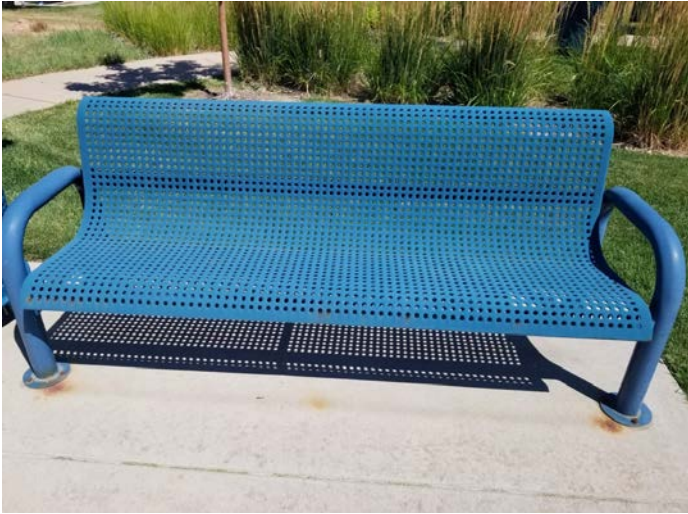
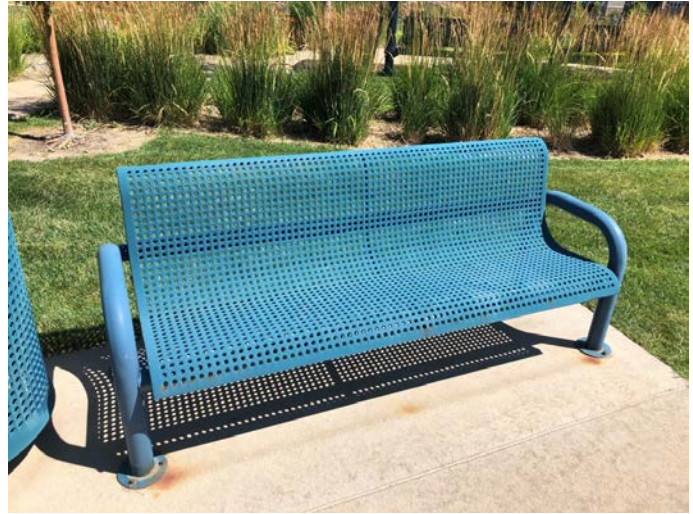
Comp #: 1307 Benches - Replace (Blue/Green)

- The average life expectancy for this type of furniture generally ranges between 12 - 18 years, depending on quality and levels of use and care.
- The remaining life is based on the average age of all furnishings.

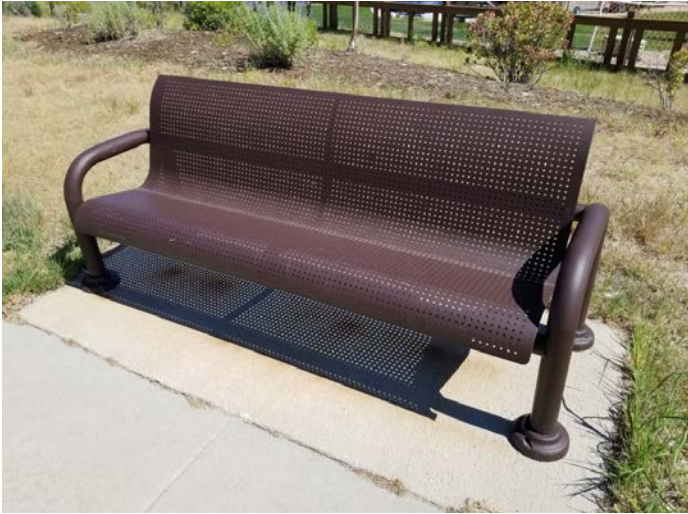
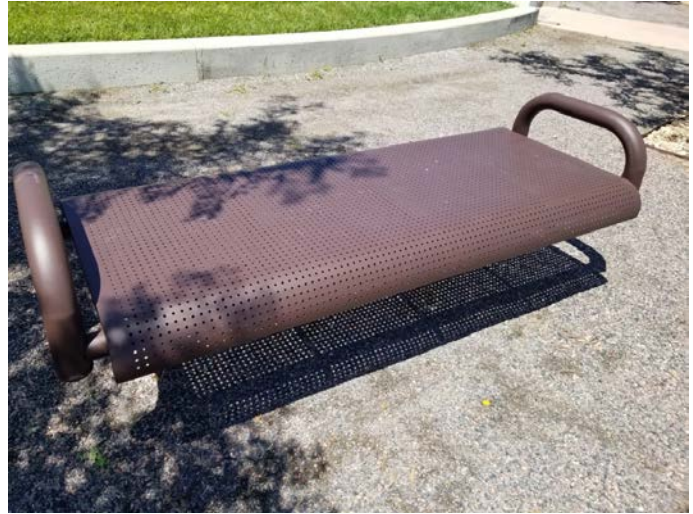
Comp #: 1307 Park Furnishings - Replace (2017)

- These furnishings were replaced and installed in 2017 and are in good condition.
- The average life expectancy for this type of furniture generally ranges between 10 - 15 years, depending on quality and levels of use and care.
- The remaining life is based on the age of all furnishings and the observed condition.

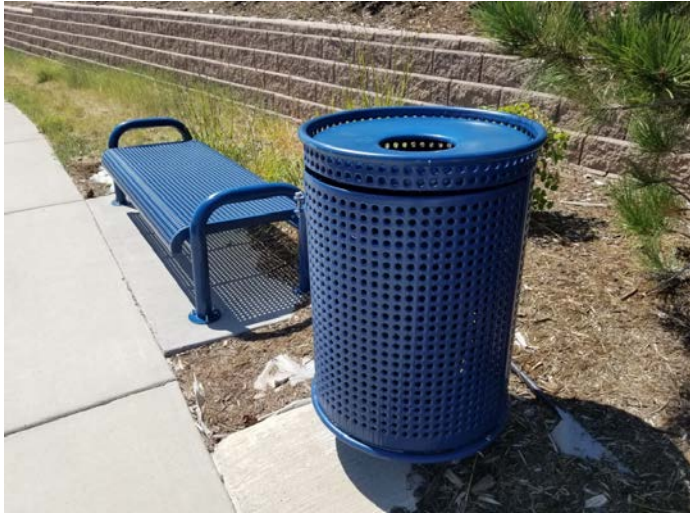
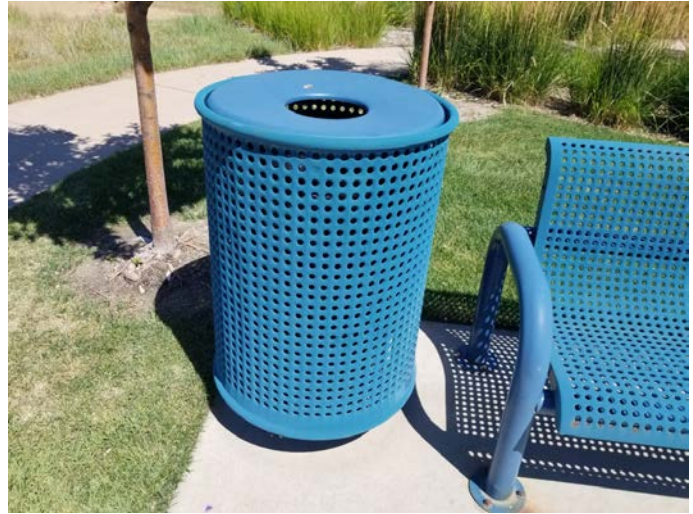
Comp #: 1308 Trash Receptacles - Replace

Location: **Common areas, parks**  
Quantity: **(7) Assorted receptacles**  
Life Expectancy: **15** Remaining Life: **1**  
Best Cost: **\$5,950**  
\$850/receptacle; Estimate to replace/install  
Worst Cost: **\$7,000**  
Higher estimate for better condition  
Source of Information: Cost Database

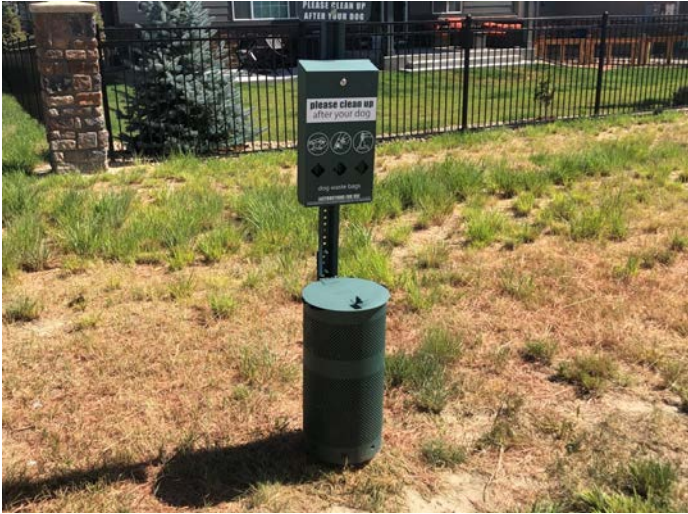
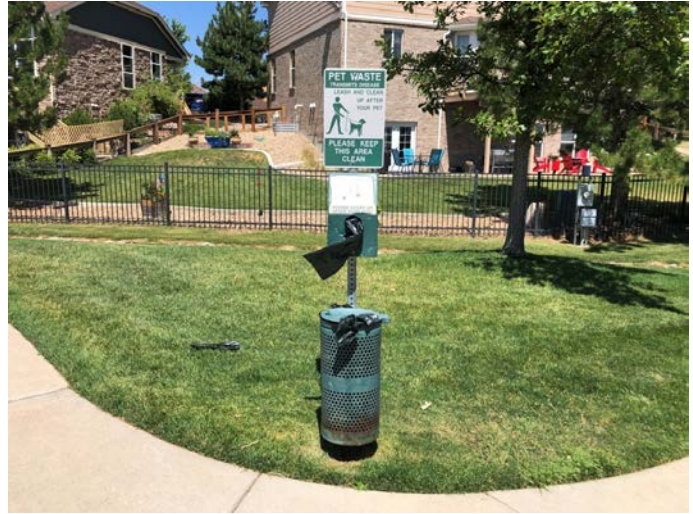
Comp #: 1311 Pet Waste Stations - Replace

- Several trash cans exhibited extensive rusting and corrosion. Dispensers appeared to be functional.
- Under normal conditions, we have seen these stations last 7 - 10 years with proper care.
- Due to the quantity, we recommend Reserving for replacement of these every 10 years.
- The remaining life is based on average age and condition.

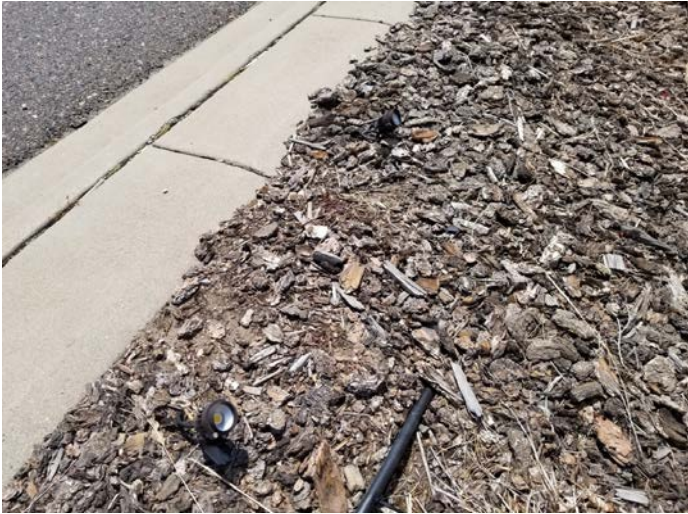
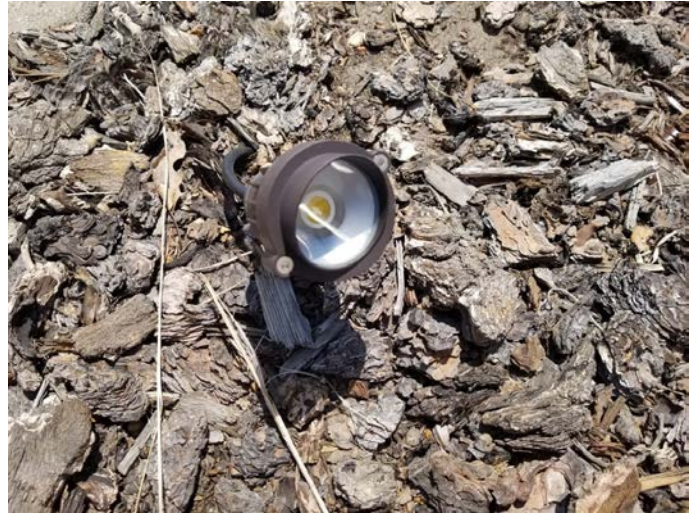
Comp #: 1603 Landscape Lights - Replace

- These are not considered "decorative" and replacement can occur on an as needed basis without disrupting the overall consistent appearance.
- No expectation to replace all lights at one time.
- We suggest replacing fixtures on an individual basis as necessary as an operating issue.
- Therefore, Reserve funding is not required at this time.

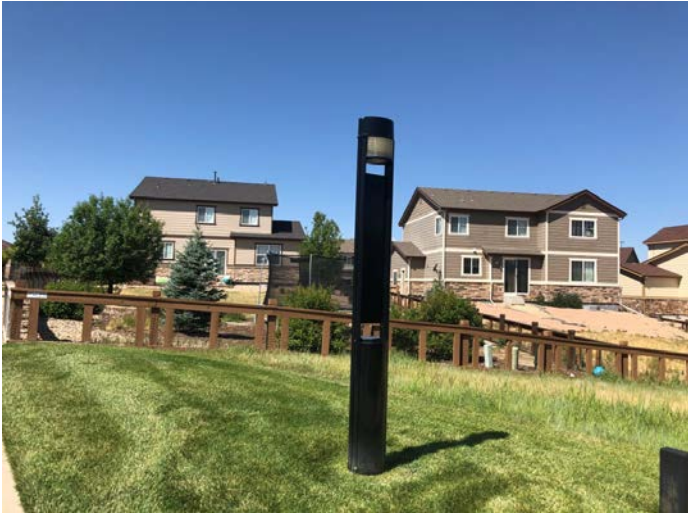
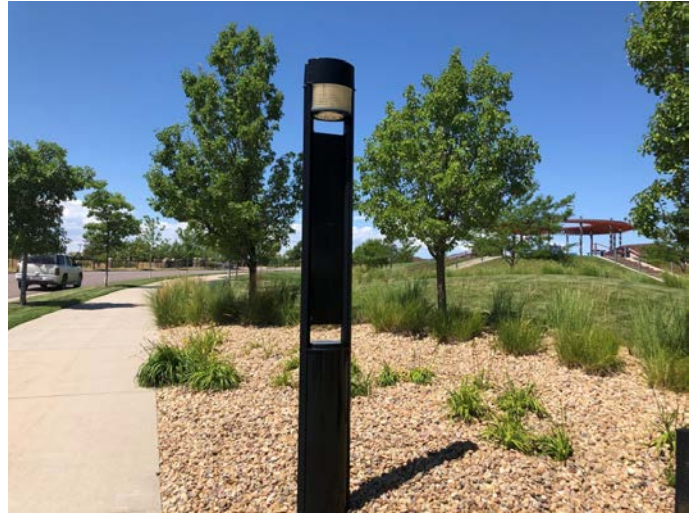
Comp #: 1604 Pole Lights - Replace

- Paint these pole lights regularly to prevent rust damage and ensure full life.
- Expect to replace these lights approximately every 25 - 30 years to maintain appearance and function.

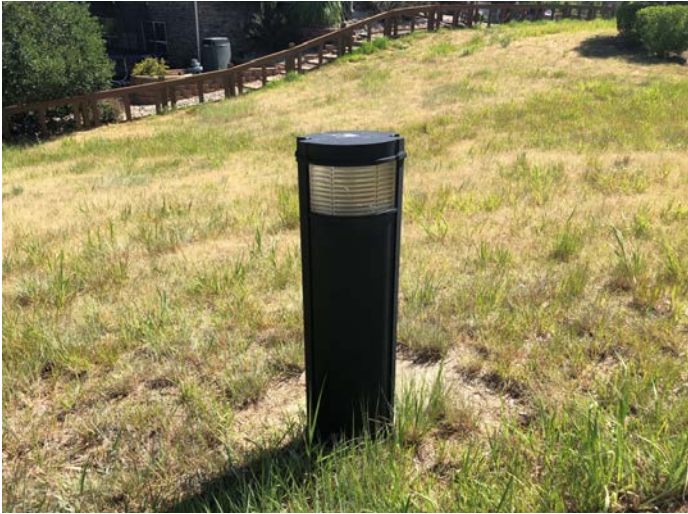
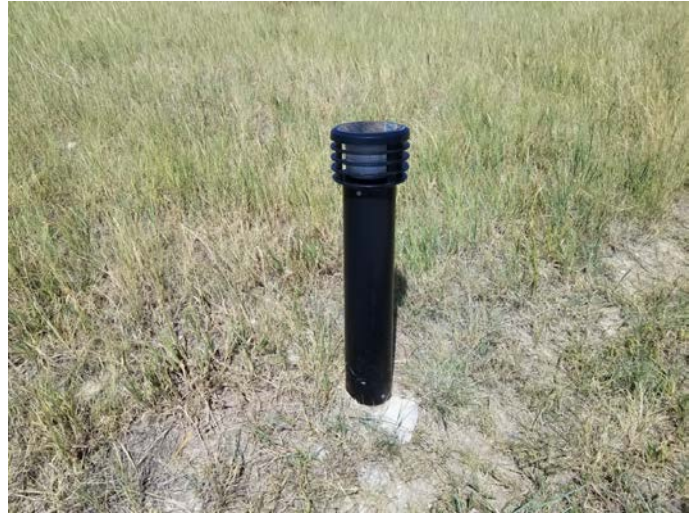
Comp #: 1605 Bollard Lights - Replace

- Conditions and ages of lights vary throughout the community.
- Due to the varying ages, we recommend establishing Reserve funds for periodic replacement of 12 lights every 6 years.
- We noted a few lights that were starting to show signs of aging and deterioration. Remaining life is based on the observed conditions.

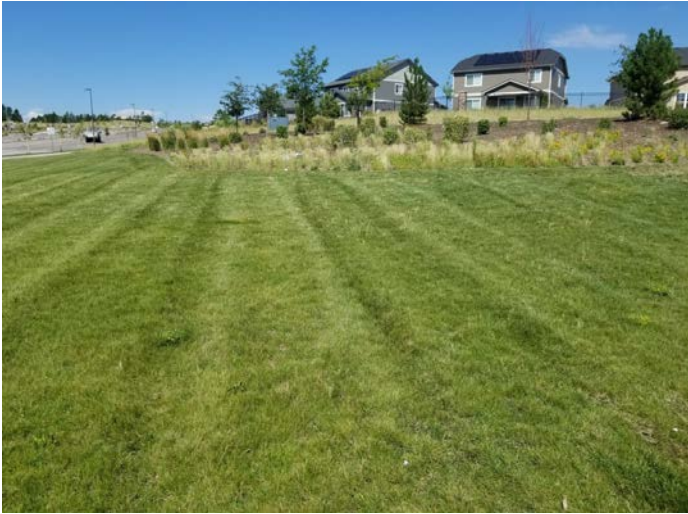
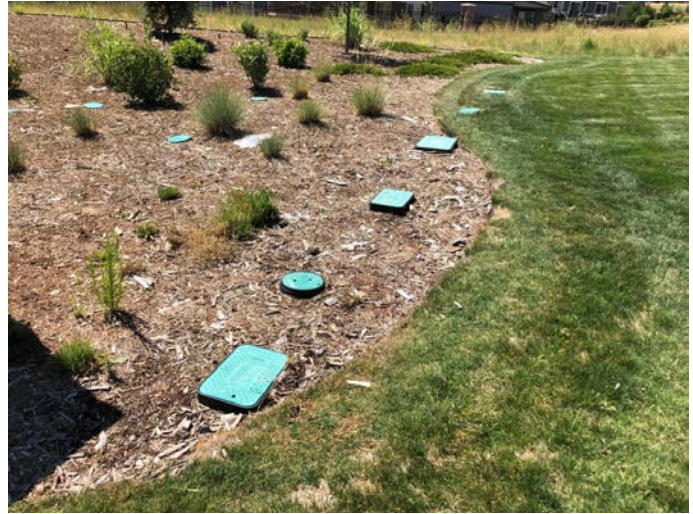
Comp #: 1701 Irrigation System - Rebuild

- This line item is for repairs and replacement that lies outside the scope of routine maintenance: bulk sprinkler head replacement, bulk valve replacement, rerouting lateral lines, rewiring, etc.
- In order to ensure the funds are available for major repairs, we recommend reserving funds for these projects every 4 - 5 years.
- The funding on this line item is for major repairs and is not to be interpreted as complete irrigation system replacement.

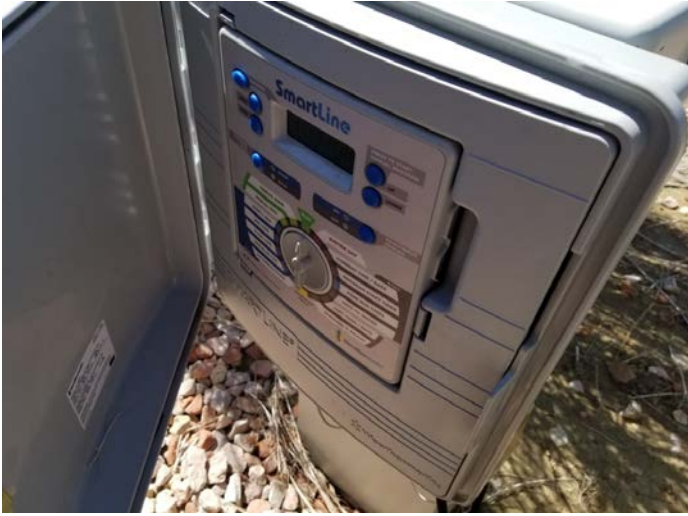
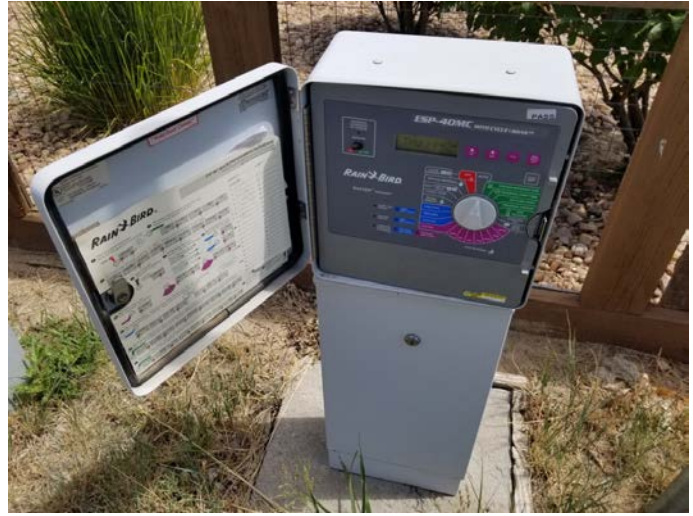
Comp #: 1703 Irrigation Controllers - Replace

- The overall life expectancy of irrigation controllers typically ranges between 10 - 12 years if properly maintained and under normal conditions.
- Due to the varying types and ages of controllers, we have established a Reserve allowance for partial replacement of controllers every 5 years.
- This line item should not be intended to be interpreted as complete replacement.

Estimate to replace 5 controllers every 5 years
