Regarding: Reserve Study Final Version

Level 1, Platinum Reserve Analysis

# Serenity Ridge Owners Association Smokey Hill Rd. & Oak Hill Aurora, CO. 80016

## FINAL VERSION

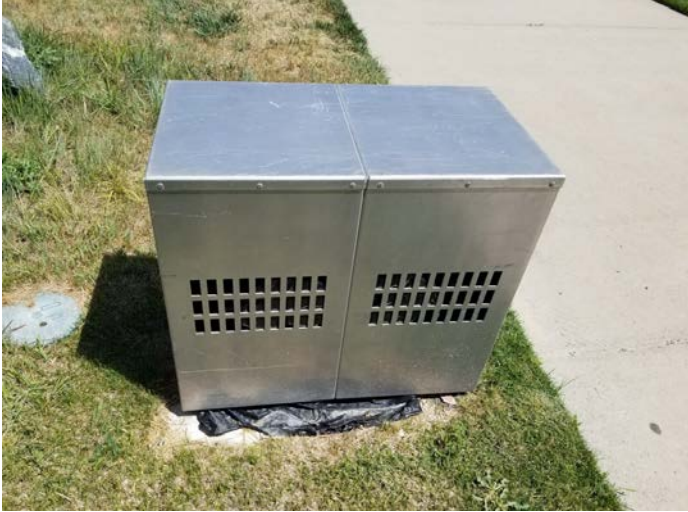
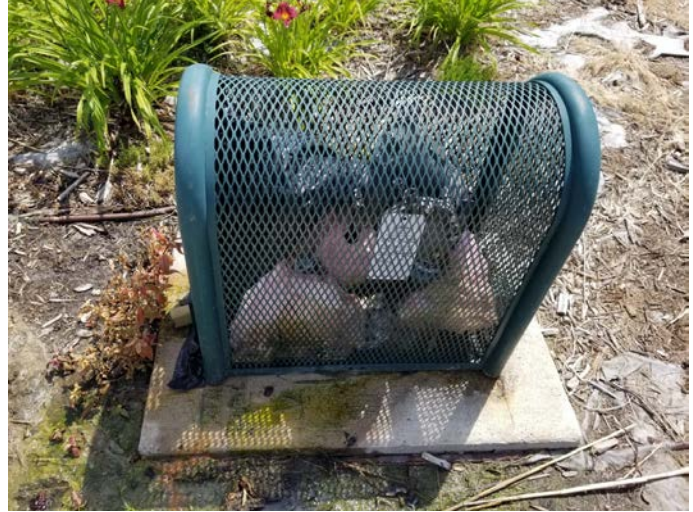
Comp #: 1706 Backflow Devices - Replace

- Leak in the backflow by Patsburg and Arapahoe. Reported this has been fixed
- All devices are enclosed in a protective cage to prevent theft. No reported problems with any of the devices.
- Due to the ability to rebuild and replace these devices for a relatively low cost and the fact that failure of the device is unpredictable, we do not recommend reserving for replacement.
- Repair and/or replace these devices/cages on an as needed basis using operating funds.

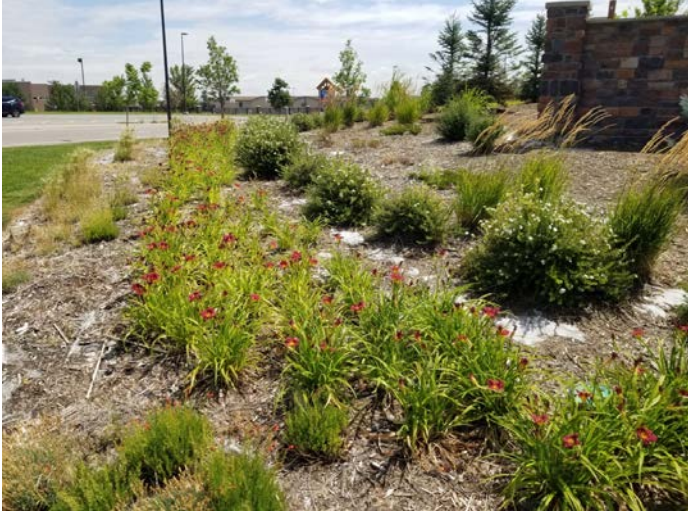
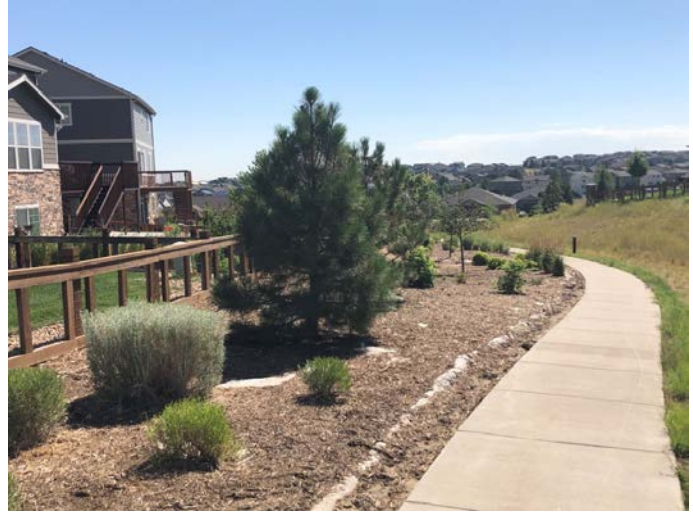
Comp #: 1801 Groundcover - Replenish

- Typically, associations will establish a line item in the operating budget to handle annual replacement of shrubs, plants, grass areas, etc.
- Therefore, separate Reserve funding is not necessary as long as funding has been established in a separate budget.
- If the association prefers to include a funding allowance for groundcover replenishment, then we would need to know how much and how often the current board of directors would prefer to set aside since this would be considered a discretionary expense.

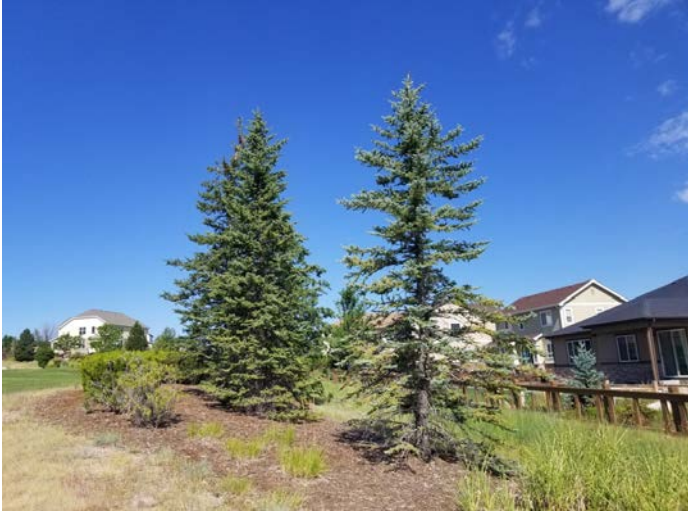
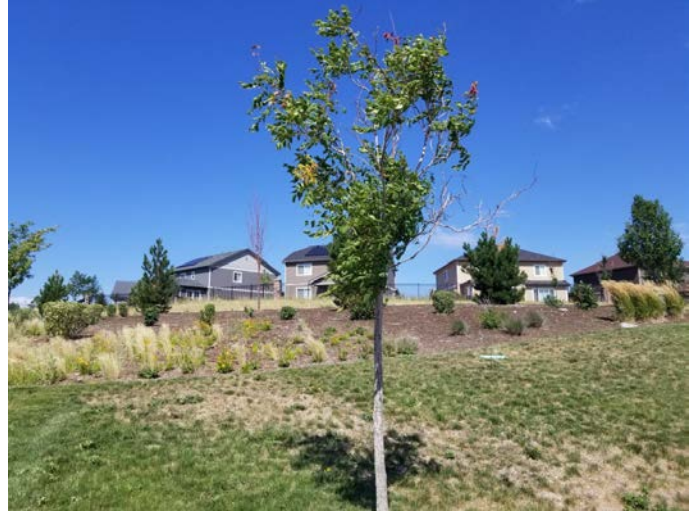
Comp #: 1804 Tree - Replacement/Major Maintenance

- It is very difficult to predict a replacement cycle for trees as there are several factors that will contribute to a tree dying.
- Factors such as disease, infestation of insects, heavy snow storms, etc. can all attribute to eventual tree replacement.
- Since it is difficult to predict when the replacement will be necessary, Reserve funding is typically not a factor.
- However, based on history of large expenses, an allowance for periodic replacement has been included.

Estimate to replace 50 trees every 3 years

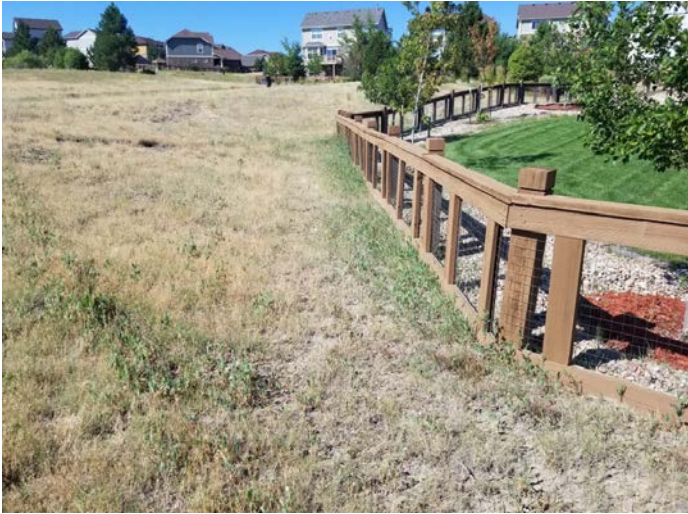
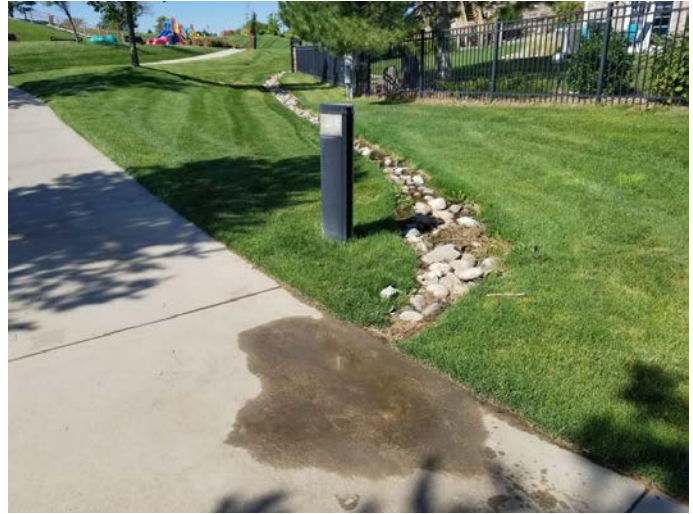
Comp #: 1813 Drainage Improvements

- Estimates received for major drainage improvements in 2021
- Based on history and reported issues, we suggest establishing funding for periodic improvements every 6 years

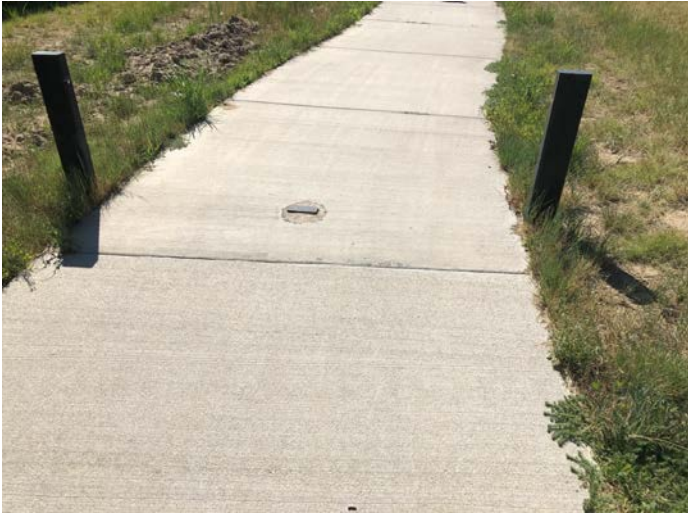
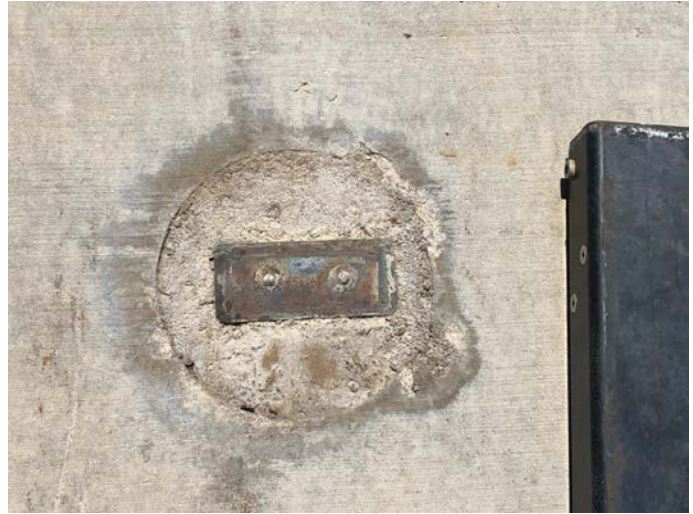
Comp #: 2005 Steel Bollards - Replace

- Under normal conditions, these bollards will have an extended life expectancy and replacement will not be required.
- Some of the center bollards are being removed and the concrete will be repaired.
- Treat any maintenance or replacement as needed with operating funds.
